THOMAS HILL RESERVOIR DAM
RANDOLPH COUNTY, MISSOURI
MO 10134

**PHASE 1 INSPECTION REPORT
NATIONAL DAM SAFETY PROGRAM**

PREPARED BY: U.S. ARMY ENGINEER DISTRICT, ST. LOUIS

MAY, 1980

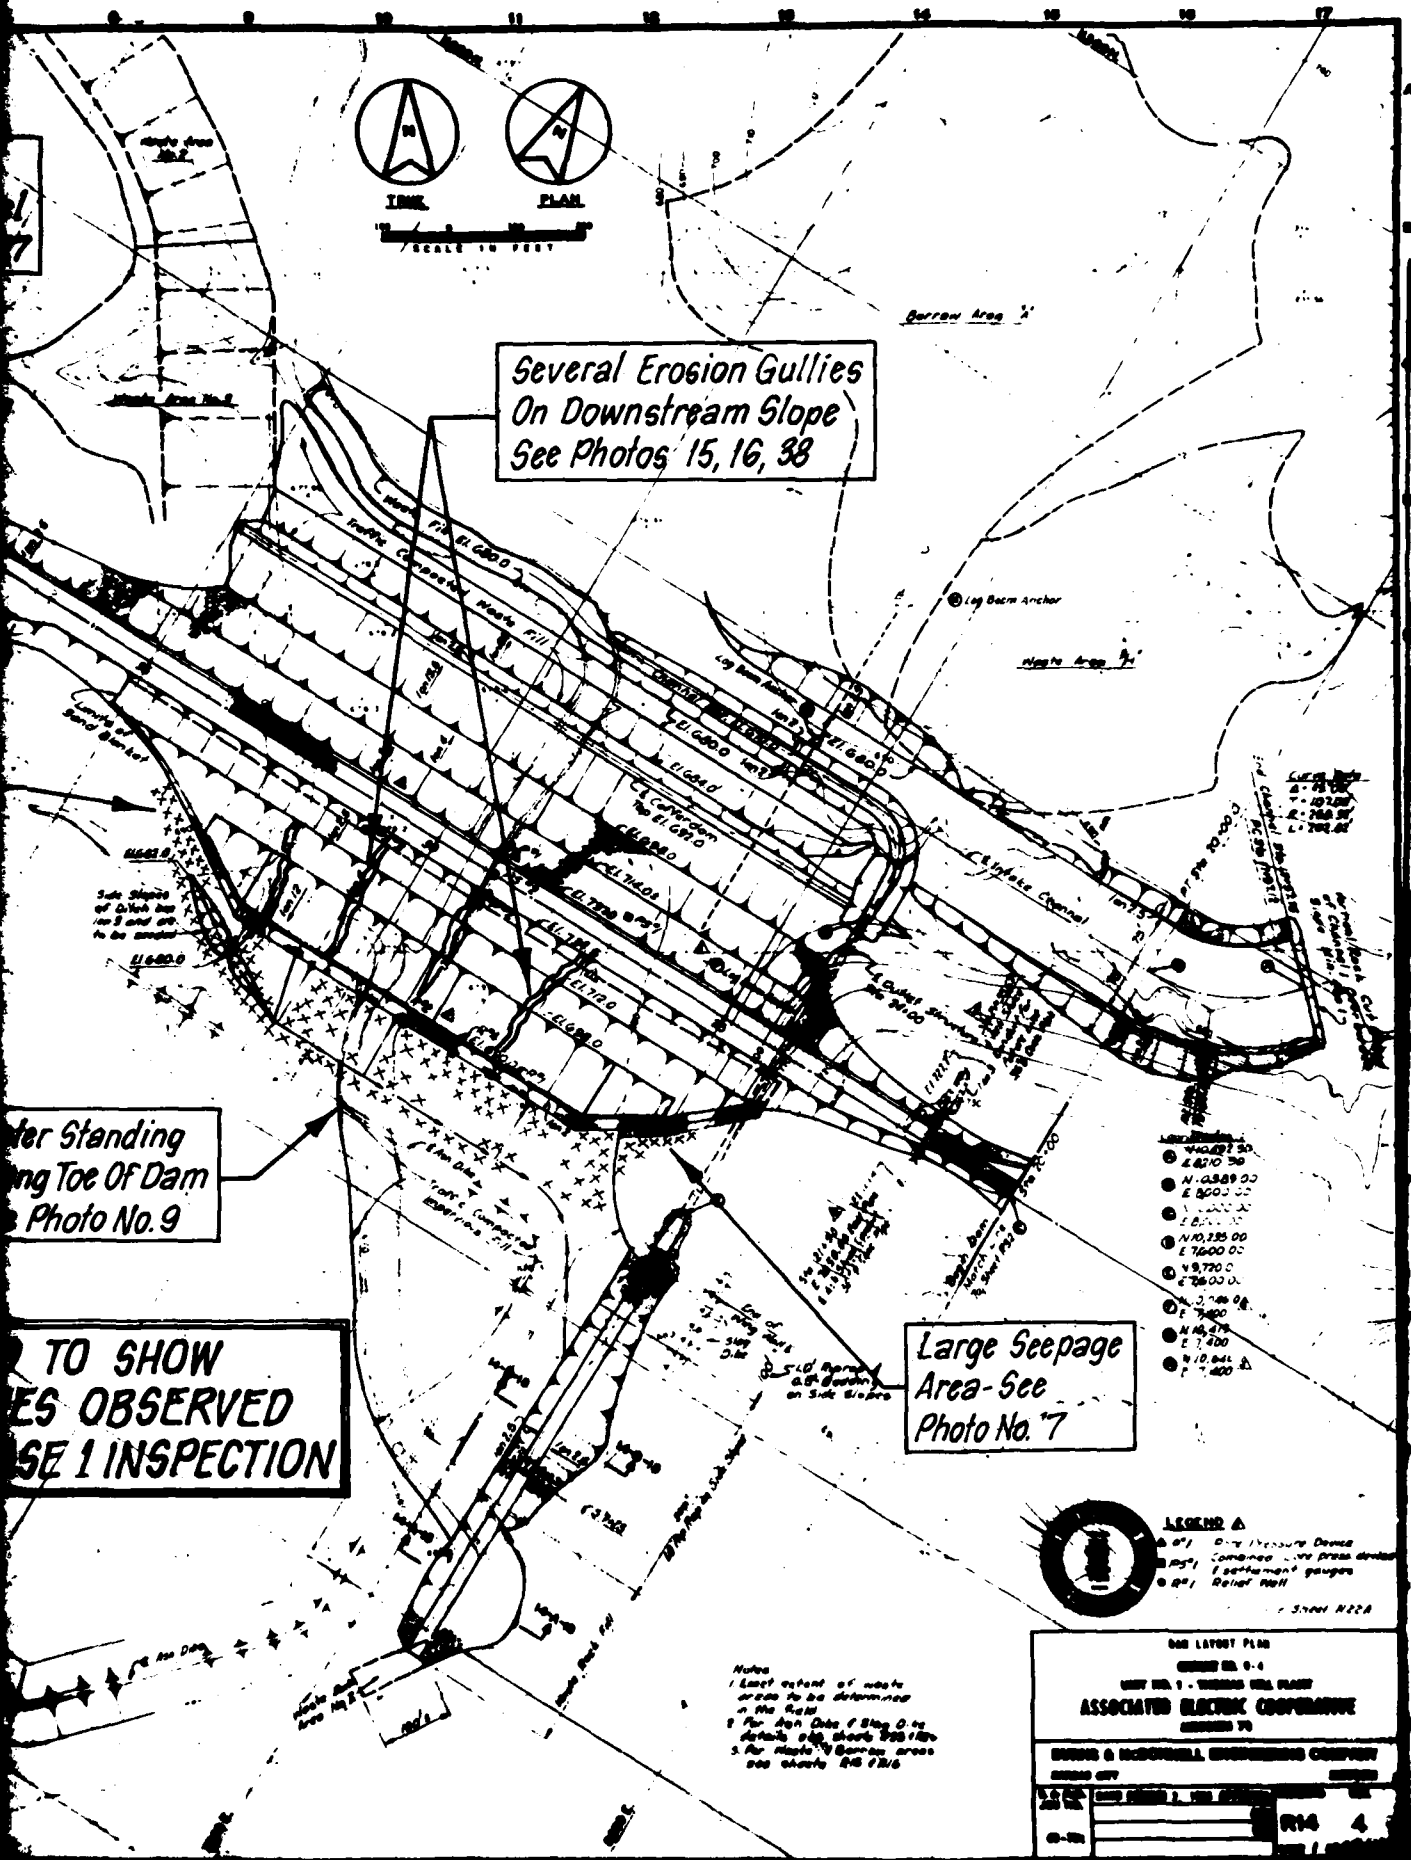
DAM LAYOUT PLAN	
UNIT NO. 1 - WINDING HILL PLANT	
ASSOCIATED ELECTRIC COOPERATIVE	
OWNED BY	
DRAWN BY	
CHECKED BY	
DATE	
SHEET NO. 1 OF 1	
PLATE C-21

Several erosion gullies, up to 2 to 3 feet deep and 3 to 4 feet wide, were observed on the slope and the berm. Photos 15, 16 and 28 show the gullies on the slope. Seepage outcrops in the left abutment trough at about elevation 697 (downstream from about Station 24+50). Seepage effluent from the left abutment was estimated at less than 5 gpm. Seepage also outcrops in the right abutment trough at about the same elevation (697) as the right abutment seep. Flow from this seep was estimated at less than 0.5 gpm. All seepage was clear. These seeps in the abutment have existed since the reservoir filled, as shown by the following quotes from records of settlement plate and piezometer readings made in 1966 and supplied by the owner. "9-19-66-The east abutment is saturated to elevation 696.58. A flow approximately 3 gpm is measurable 80 feet south of Station 24+60. Another seep, at the same elevation, is evident on the west abutment near the head of the original ditch located 250 feet south of Station 35+50. The rate of flow is too low to be computable at this point." According to the plans, the areas upstream to the sides and below the elevations of the seeps are included in the grout curtain area.

Several Erosion Gullies
On Downstream Slope
See Photos 15, 16, 38

Water Standing
Along Toe Of Dam
See Photo No. 9

Maintenance of the structure is generally good. A few trees on the downstream slope and in the emergency spillway exit channel should be removed, and the erosional gullies on the downstream slope should be repaired.
